Taiwan 403 Earthquake: Protections for Semiconductor Industry from Seismic Damages

June 2024

Bruce Lee

SVP, Risk Management, Taiwan
bruce.lee@lockton.com

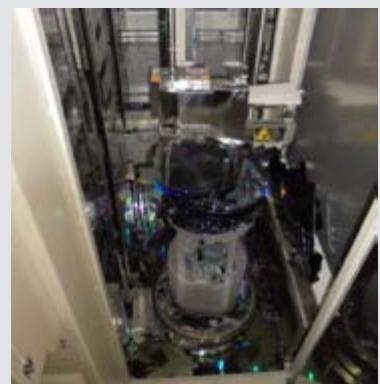
WIP Wafers and quartz tubes breakages inside the Vertical Diffusion Furnace

It is commonly known that vertical diffusion furnaces (VDFs) are most vulnerable to damage from earthquake among all process equipment. Facilities mostly experienced damage to the internal quartz components in their equipment during earthquakes. In some cases, over 60% of their VDFs had damage to the quartz tubes and quartz made internal parts.

VDFs come with tall setups of over 3 meters high in some cases. It was postulated that the internal shaking experienced during the earthquake was sufficient to crack the quartz tubes at their bottoms (which rested on baseplates) from stress and at tops due to impact. Thousands of WIP wafers were also thrown away from their VDFs and broke in the event.

In order to completely solve the problem of wafers and the quartz components damage inside VDFs, a seismic isolation platform with friction pendulum system (Fig. 1) was successfully developed to effectively protect the parts from damages by earthquake events. The charts on the right (Fig. 2) show the comparison of VDF acceleration responses, under the achieved PFA of 70 gal. The maximum displacement reads 10 cm, which is well within the allowed displacing capacity of 18 cm reserved for the VDF. Evidently, all the recorded acceleration responses are remarkably reduced when the VDF is controlled with the isolation platform. The illustration of the isolation platform is shown in the pictures below (Fig. 3).

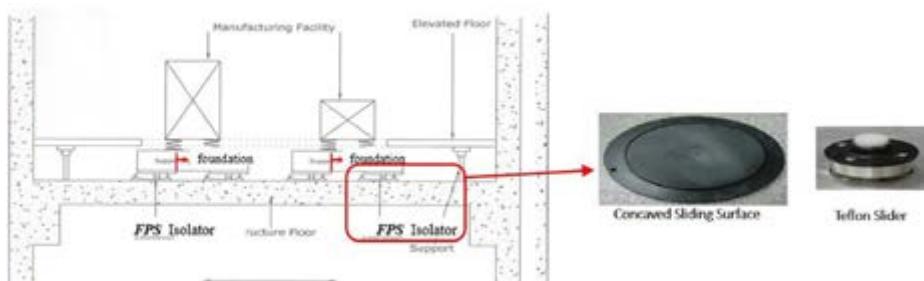
Fig. 1 Seismic Isolation Platform w/ Friction Pendulum System (FPS) (photo courtesy of NYCU)

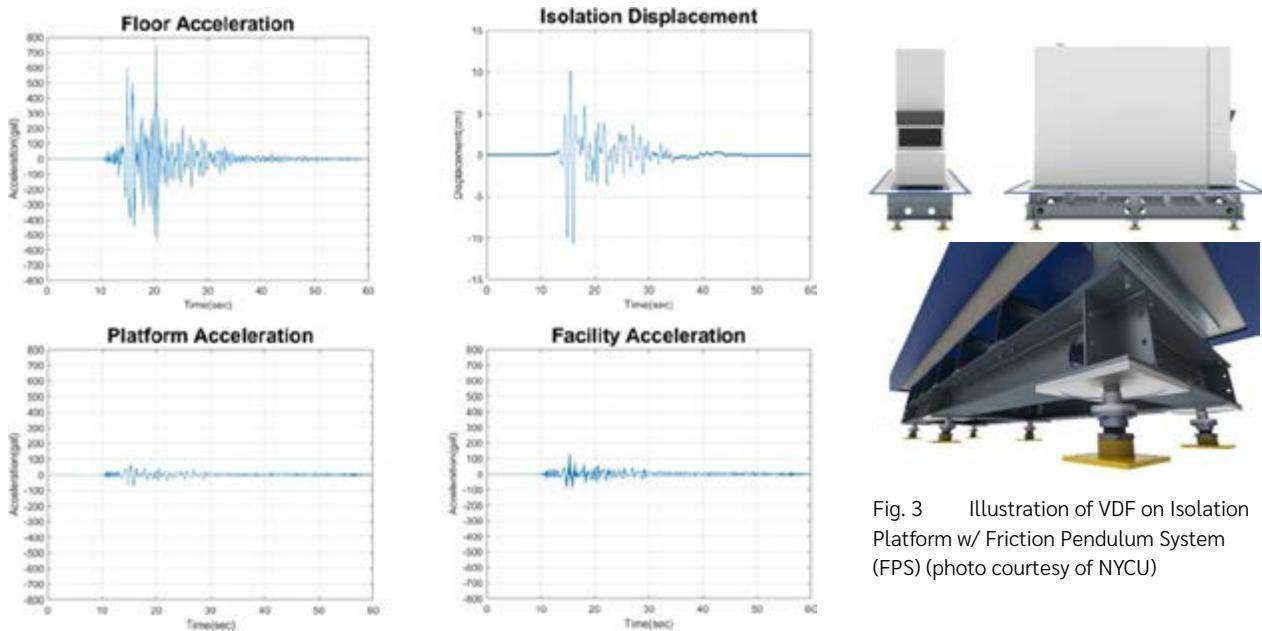
Fig. 2 Full-scale test result for Kobe Quake 700 gal. The vibration of the VDF is minimized when the friction pendulum system is implemented (photo courtesy of NYCU)

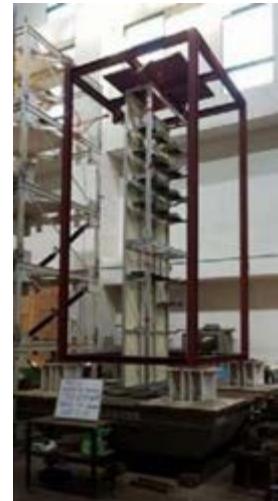
During the earthquake, the storage cassettes (FOUPs) slid and collided with stocker frames which caused damage to the wafers inside. Several FOUPs were even shaken off from the stockers and created wrecks which

were difficult to remove. In view of this, seeking effective earthquake protection measures for the stockers has the highest priority among all to mitigating seismic risks.

Fig. 4 Stocker and frame implemented on the shake table (Photos courtesy of NYCU)

Lockton Taiwan's Risk Consulting team, with help from a professor of National Yang Ming Chiao Tung University (NYCU), conducted a series of shake table tests to verify feasibility of our proposed scheme applied to an industrial, full-scale stocker under realistic earthquake scenarios (Fig. 4).

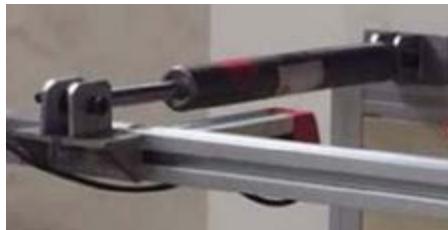
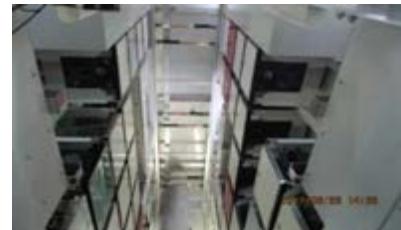
Fig. 5 Viscous fluid dampers provided on top of Stockers (Photos courtesy of Lockton client & NYCU)

This scheme has been proven successful in meeting the desired seismic performance. It met with the loss control goal of preventing wafer damage from sliding off the stockers or falling to the ground (Fig. 5).

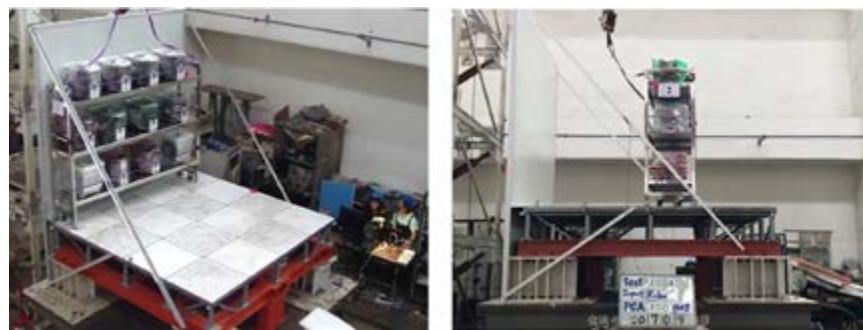
It is a common practice to lock the four wheels of a cart when it is in position. This can prevent the table from sliding in cleanrooms. However, it has been proven to be a wrong approach from the perspective of earthquake prevention after the 2016 Tainan earthquake (206 Quake). During that incident, a lot of locked wafer/reticle carts and hundreds of tall and narrow carts were tipped over, resulting in serious wafer/reticle losses.

Fig. 6 Wafer/reticle cart implemented on the shake table (Photos courtesy of NYCU)

In view of this, we have also conducted a series of full-scale tests on wafer/reticle carts (Fig. 6) to find ways to prevent them from tipping over during an earthquake. Our tests proved that the wheels of all the wafer/reticle carts should have their brakes off to prevent tipping over during earthquakes.
